REPUBLIC OF CYPRUS
MINISTRY OF COMMUNICATIONS AND WORKS

ANNUAL REPORT
OF THE
DEPARTMENT OF ANTIQUITIES
FOR THE YEAR
1990

By
A. PAPAGEORGHIU
Director of the Department of Antiquities

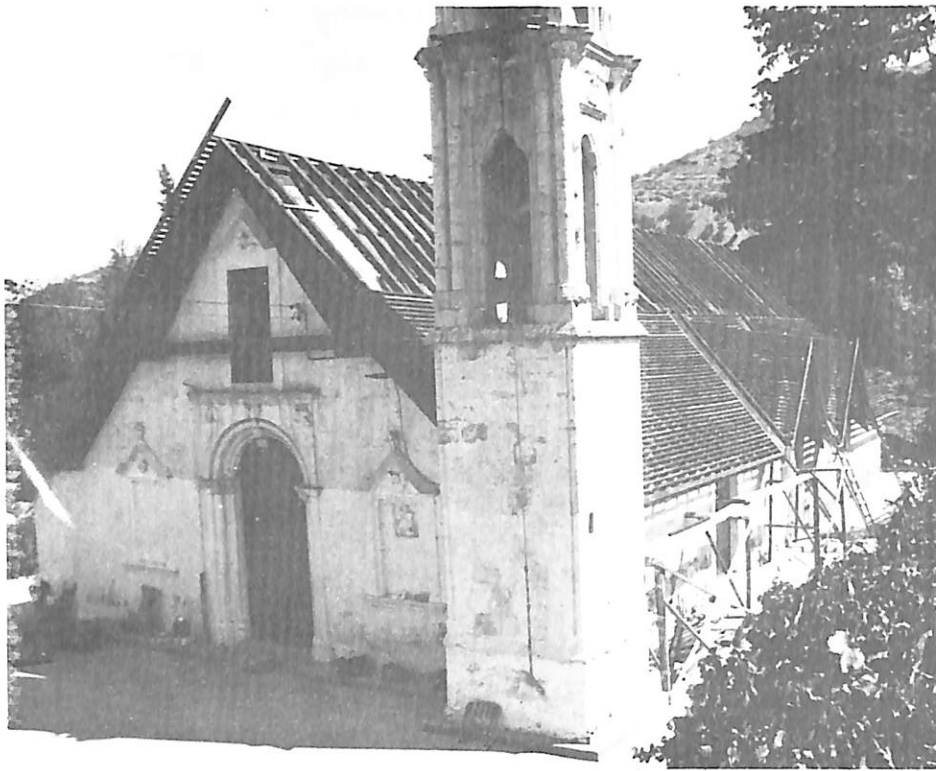
5. Alona, Church of Agios Georgios, during restoration work of the roof.

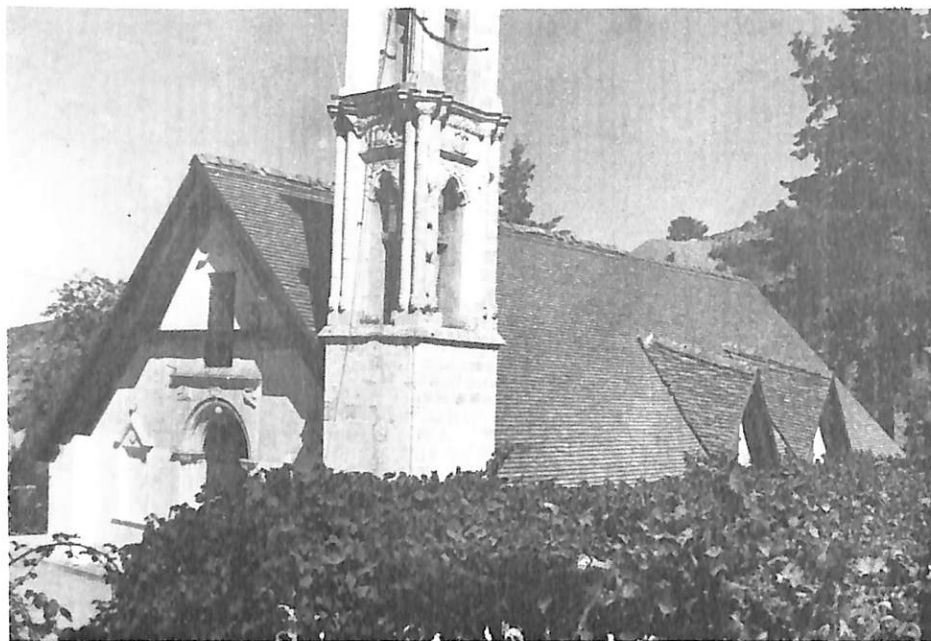
6. The same as above, after completion of the work.

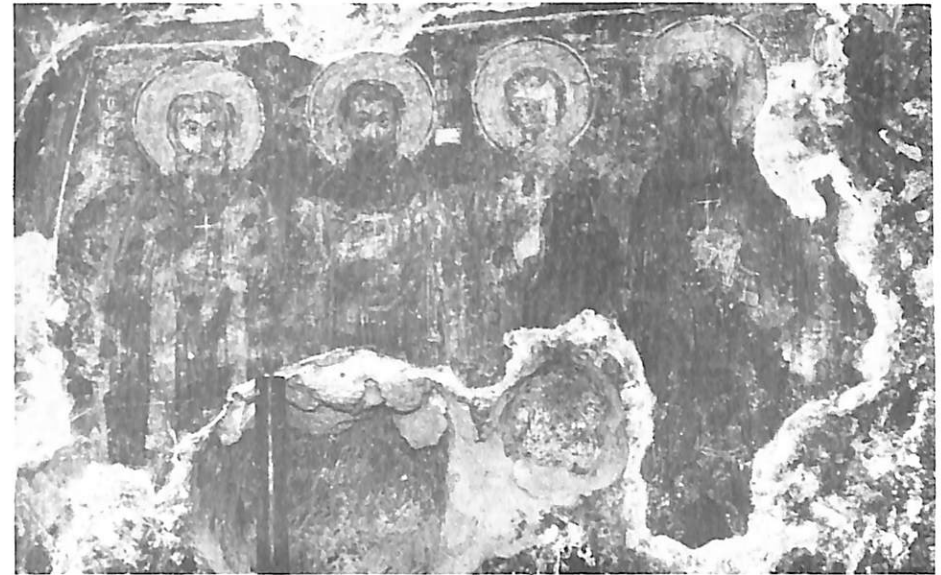
7. The same as above, during restoration works.

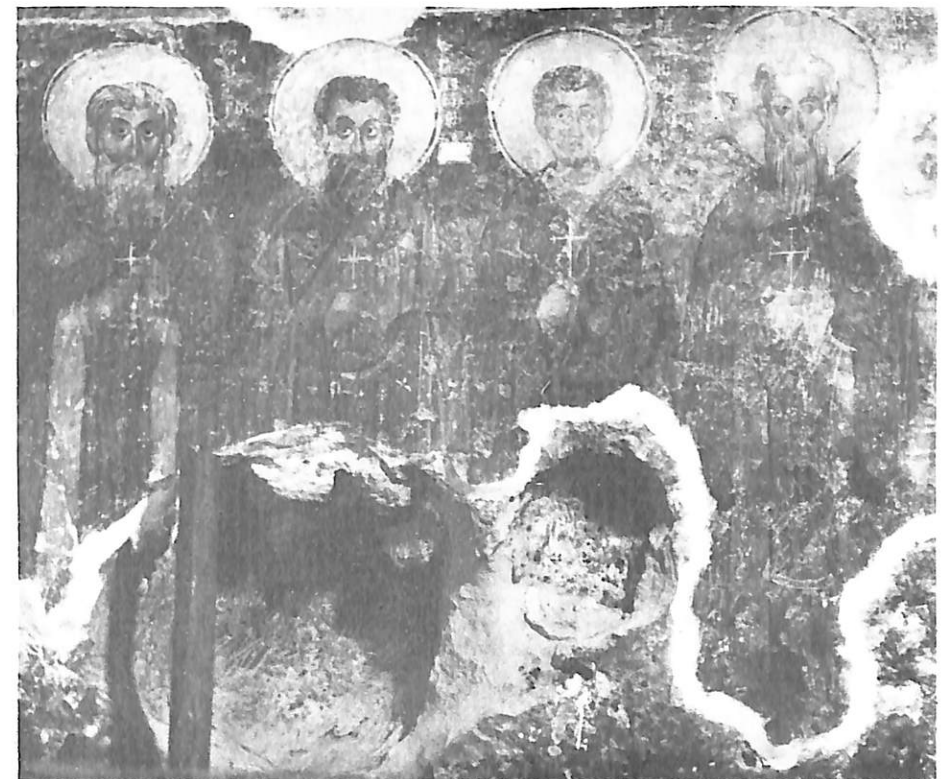
The eyes of some of the Saints were gouged out by the Turkish shepherds of the nearby village of Agios Sozomenos. The infiltration of rain water through the porous rock also caused some damage to the wall-paintings. On the wall, above the tomb of the Saint, two layers of wall-paintings were noticed during conservation. Since the later layer was badly damaged it was decided to remove it and uncover the earlier one. On the earlier layer four standing Saints in more or less good condition were found and cleaned. Work was continuing at the end of the year. (Cost : £5,917, shared with the Archbishopric).

8. Agios Sozomenos. Rock-cut chapel of Agios Sozomenos. Four standing Saints after restoration work.

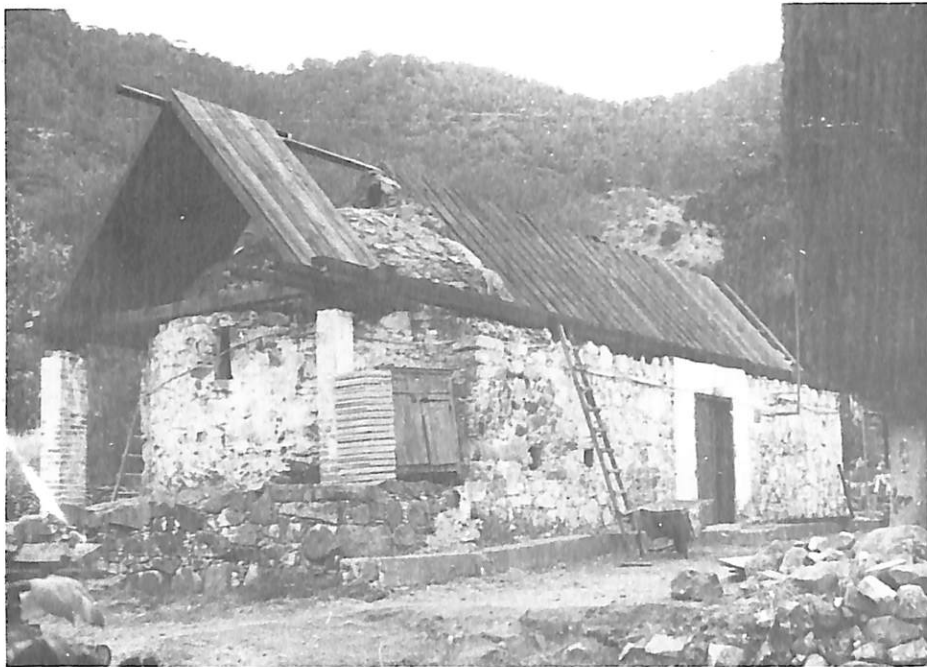
Kannavia, the Church of Agia Eirini.—(Figs 9,10). This is a small steep pitched wooden roofed Church. Its roof was badly damaged and in need of repair. The decayed wooden beams and trusses, as well as the broken flat tiles were replaced, the latter with new ones of the same type. (Cost : £6,886, shared with the Church Committee).

9. Kannavia. Church of Agia Eirini, during restoration of the roof.

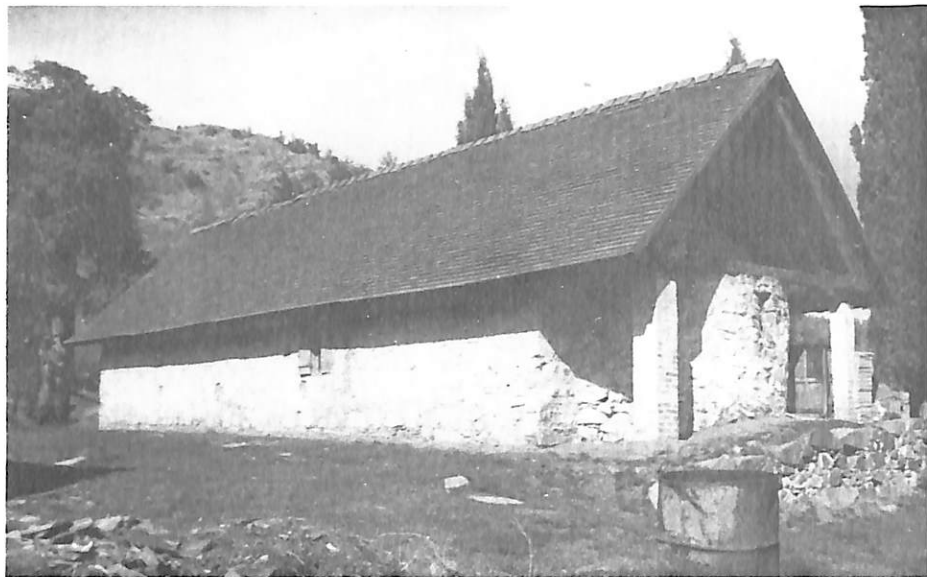
10. The same as above, after completion of the works.

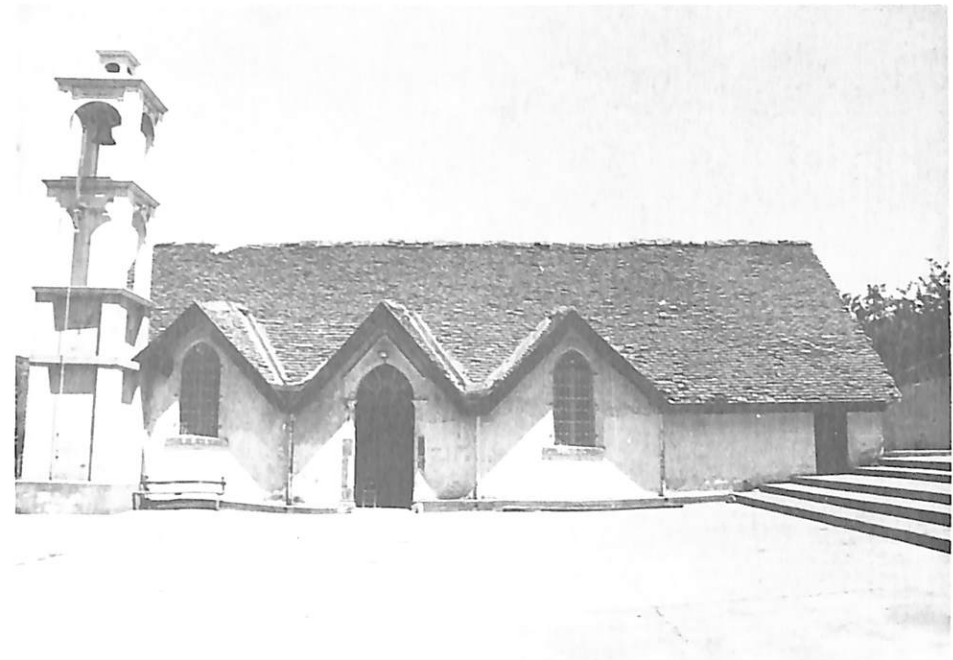
Platanistasa, the Church of Archangelos.—(Figs 11,12). The Church of Archangelos at Platanistasa, is, in its present form, a large, three aisled basilica covered with a steep pitched wooden roof and flat tiles of the 19th century. During the twenties, the southern half of the roof was provided with gables, above the south entrance and the windows which were opened at that time. The roof of the Church was badly damaged by dry rot and the infiltration of

rain water and was ready to fall down. The decayed wooden trusses, the beams and planks were replaced and missing or broken tiles were also replaced. (Cost : £19,306, shared with the Church Committee).

11. Platanistasa. Church of the Archangel Michael, before the restoration of the roof.

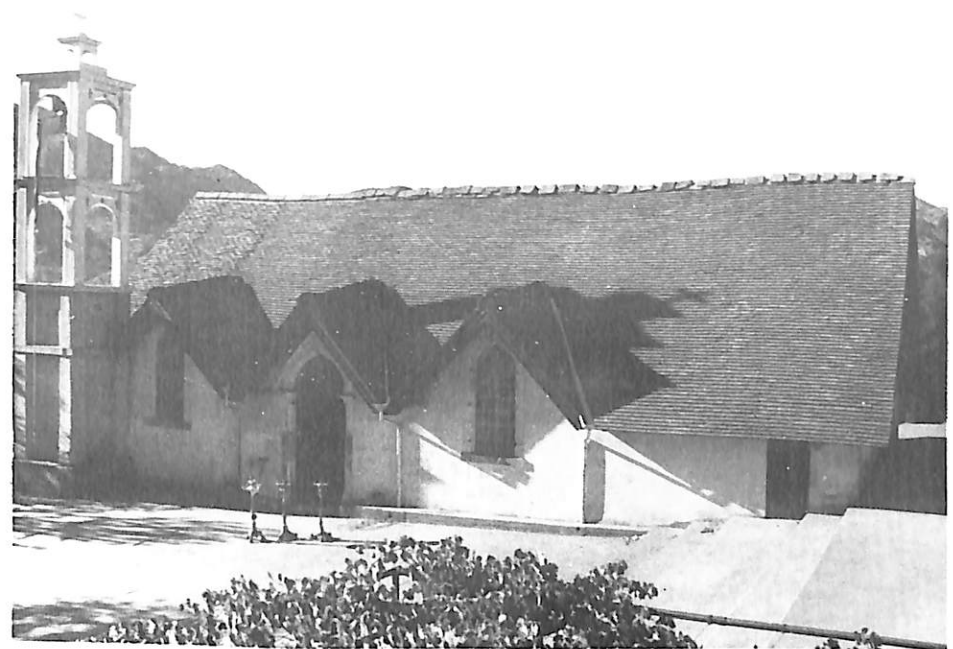
12. The same as above, after the completion of the works.

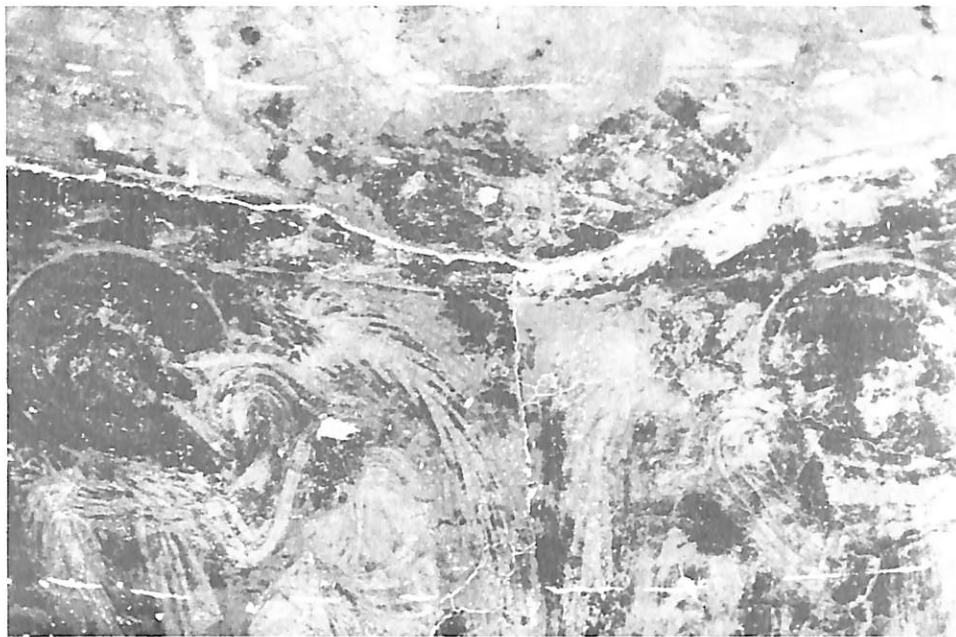
13. Strovolos. Church of Panagia Chryseleousa. Wall-paintings of the dome before the restoration work.

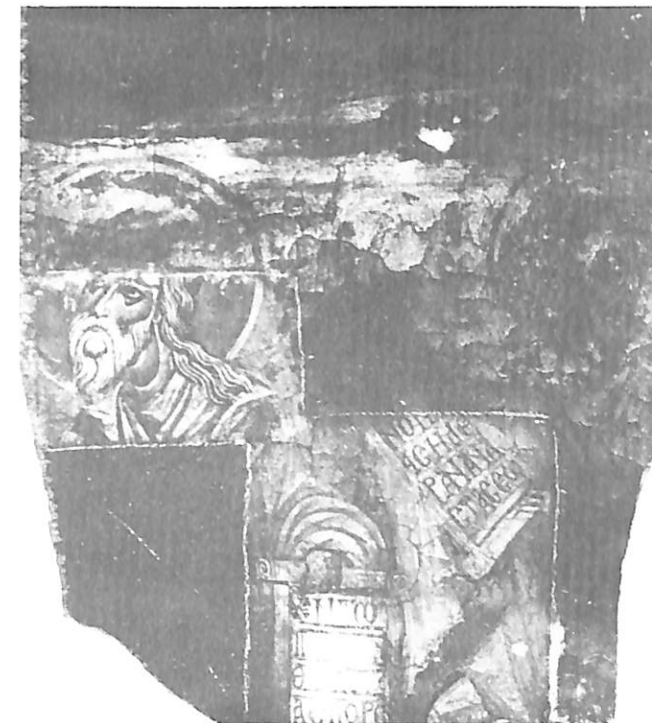
15. Strovolos. Church of Panagia Chryseleousa. Wall-painting of the dome during restoration work.

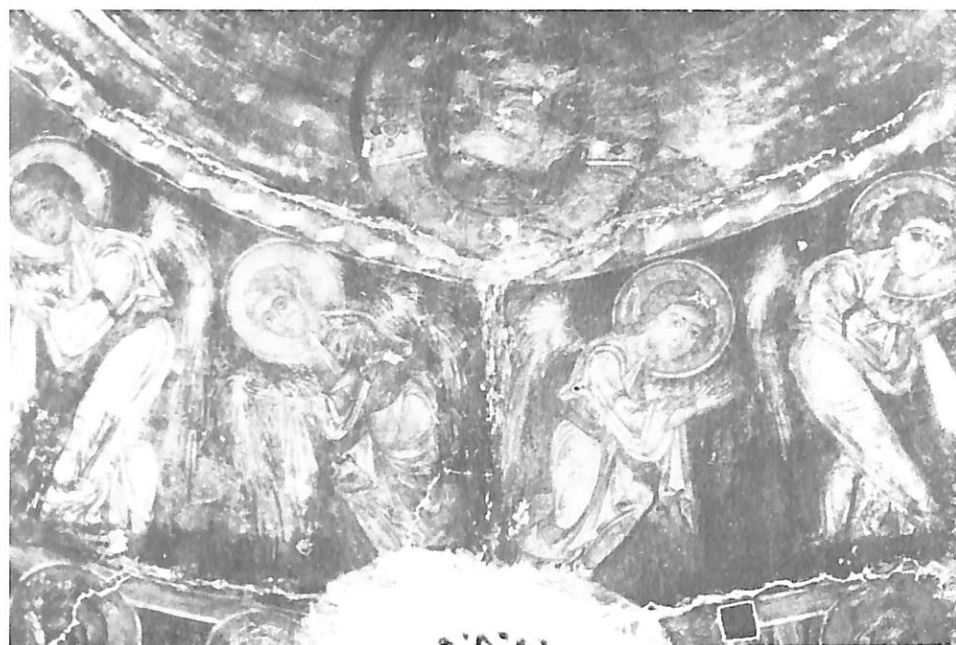
14. The same as above, after the restoration work.

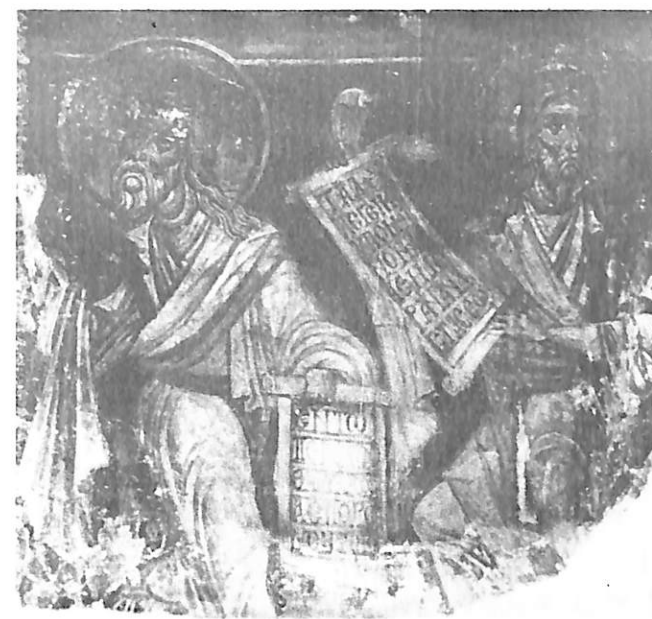
16. The same as above, after the restoration work.

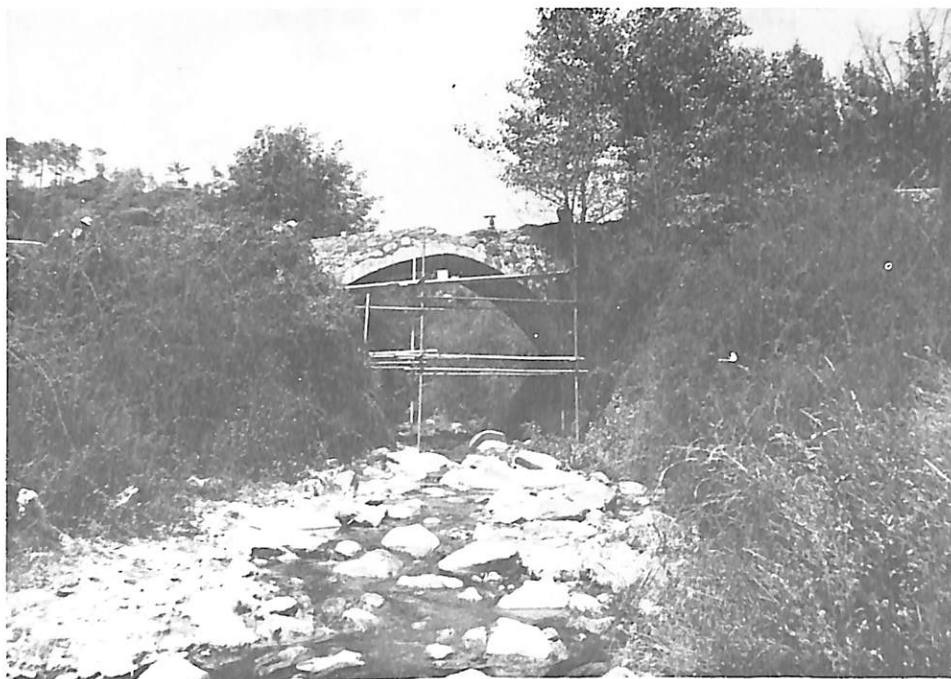
Pelendri, the Mediaeval bridge of Kouris.*—(Figs 17,18). The mediaeval bridge over the river Kouris at the locality *Kardaki* was in need of repairs. Two missing key-stones were replaced. The masonry of the bridge was grouted and pointed. (Cost : £779).

17. The bridge at "Kardaki", near Pelendri, during restoration.

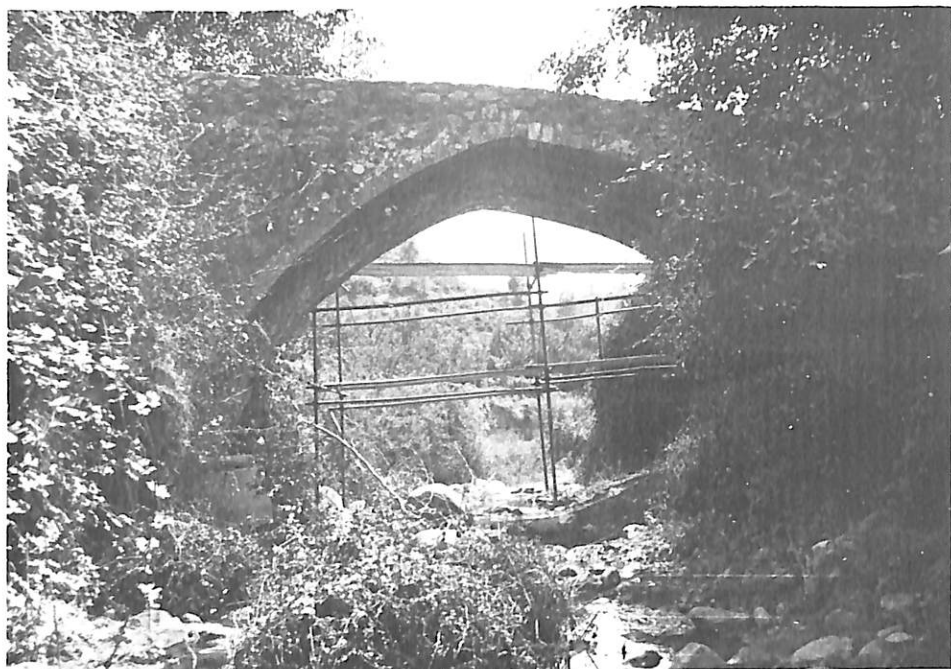
18. The same as above, after the restoration.

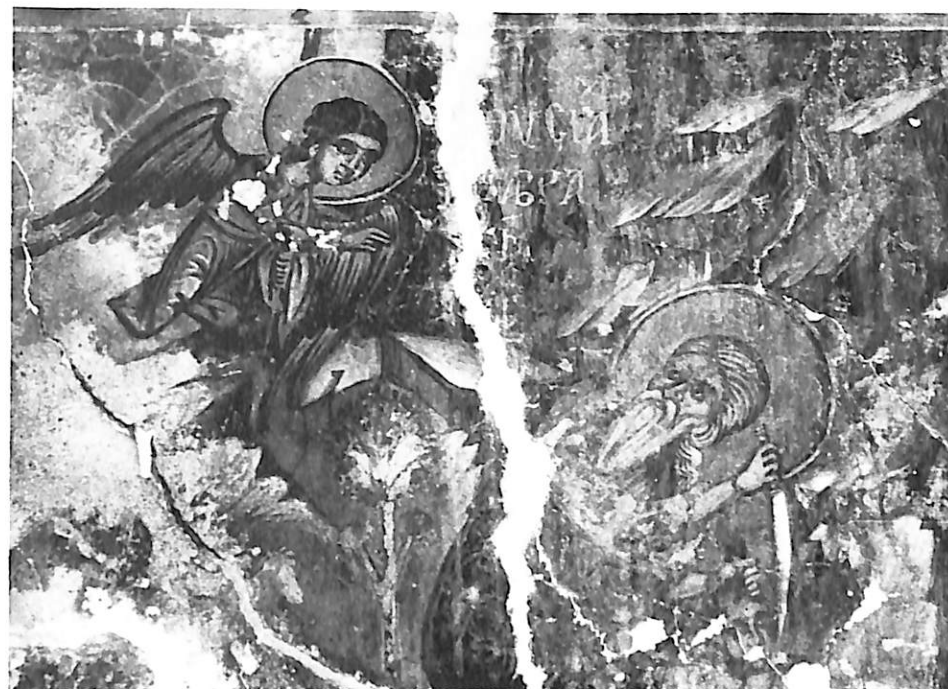
19. Kolossi. Church of Agios Efstathios. The Sacrifice of Abraham, wall-painting in the Bema during restoration work.

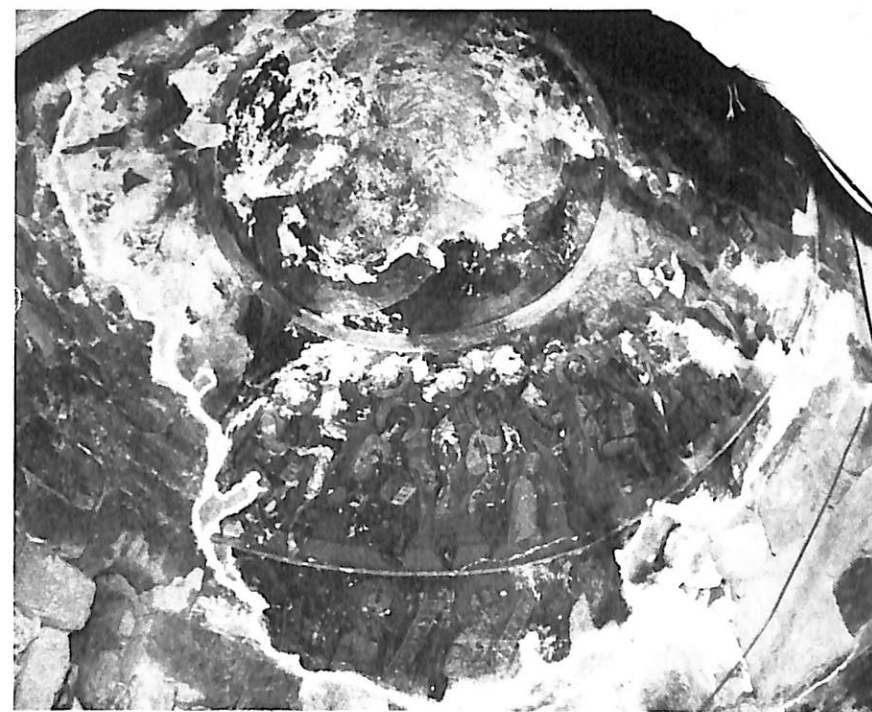
20. Kolossi. Church of Agios Efstathios. Wall-paintings of the dome, during restoration work.

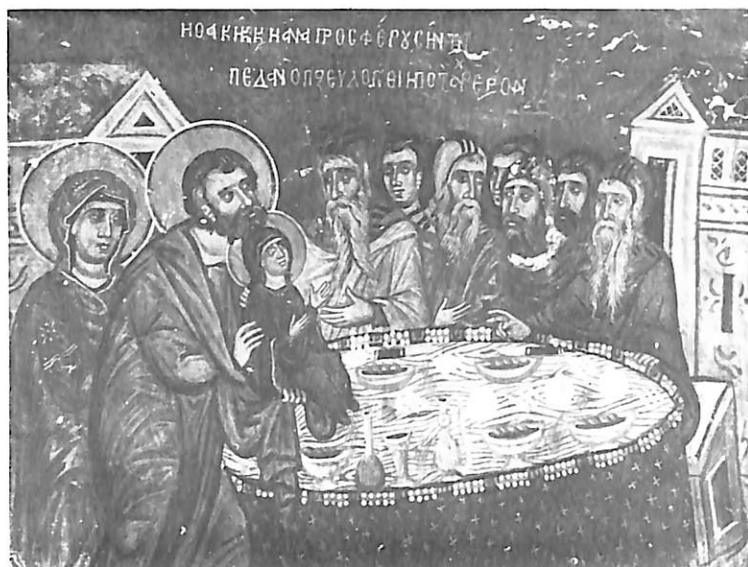
Pelendri, the Church of Timios Stavros.—(Figs 21, 22). The cleaning and conservation of the wall-paintings of the Church of Stavros was resumed in May. The wall-paintings of the west-wall of the main Church including the Crucifixion were cleaned. The wall-painting of the Dormition of the Virgin in the lunette of the western blind arch of the north wall, which had become detached and broken was removed and reset, and treated accordingly. The scenes with Christ before the High Priests and Pilate in the lunette of the central blind arch of the north wall were cleaned. The Angel of the Annunciation in the eastern half of the soffit of the same arch was also treated. The wall-paintings in the north chapel were cleaned. These include, the "Doubting of Thomas", two Apostles, a coat of arms, the three prelates St. Basil, St. Gregory and St. John Chrysostomos and the portrait of Leon Skouleas. After the removal of plaster from the west wall of the south chapel, more scenes from the martyrdom of St. George were revealed. The cleaning and preservation of the wall-paintings of the Church will continue next year. (Cost : £8,260, shared with the A.G. Leventis Foundation).

21. Pelendri. Church of Timios Stavros. Wall-painting of the Blessing of the little Virgin Mary, at the south side of the vault.

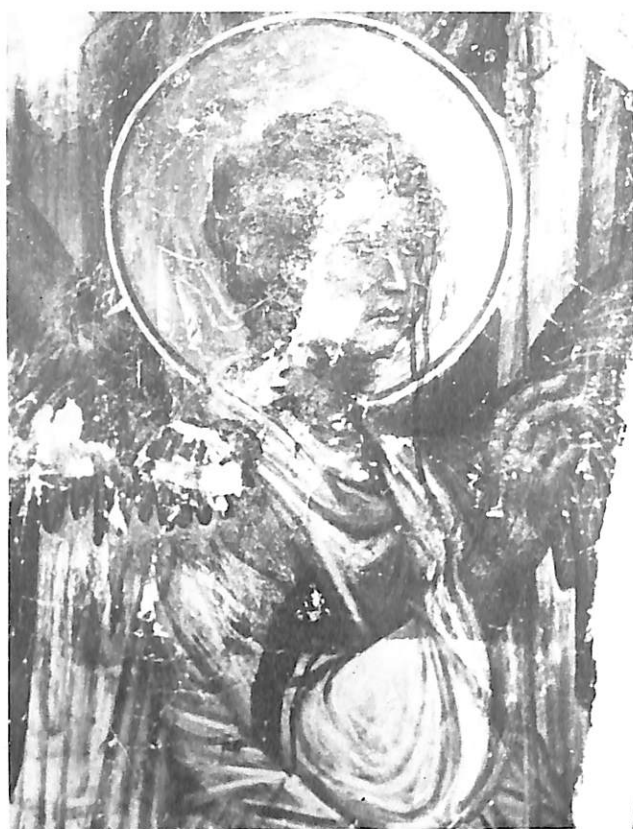
22. Pelendri. Church of Timios Stavros. Wall-painting of an angel, after restoration work.

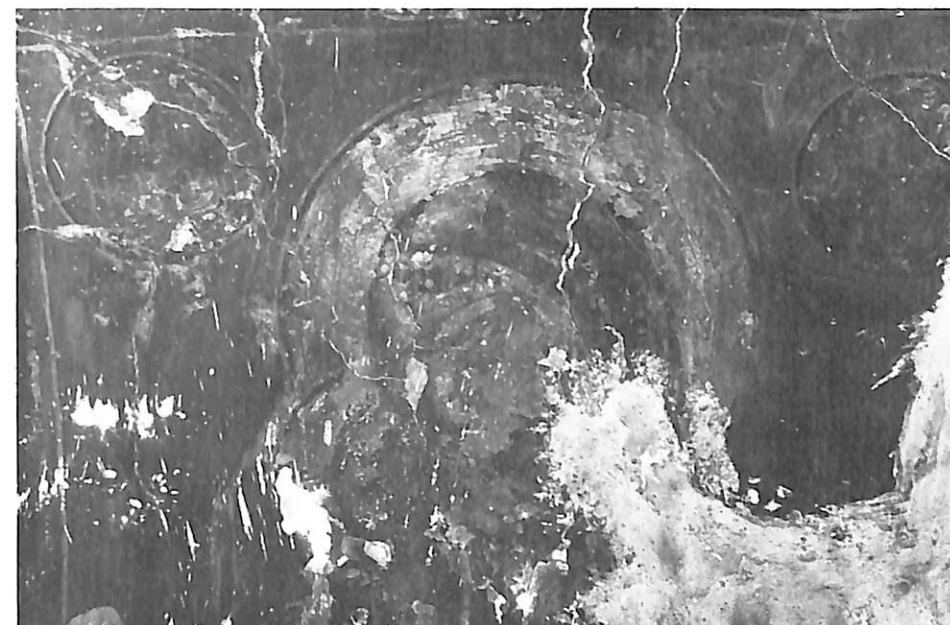
Letymbou, the Church of Agii Kirikos and Ioulitta.—(Figs 23, 24). The cleaning and conservation of the wall-paintings of the Church continued during May-August. After the removal of a thick layer of plaster from the south wall, some standing Saints and a damaged St. George mounted on a horse were discovered and treated. Some supplementary treatment of the wall-paintings of the eastern and northern vaults was carried out. (Cost : £4,604, shared with the A.G. Leventis Foundation).

23. Letymbou. Church of Agii Kirikos and Ioulitta. Wall-painting depicting Panagia Kykkotissa before restoration work.

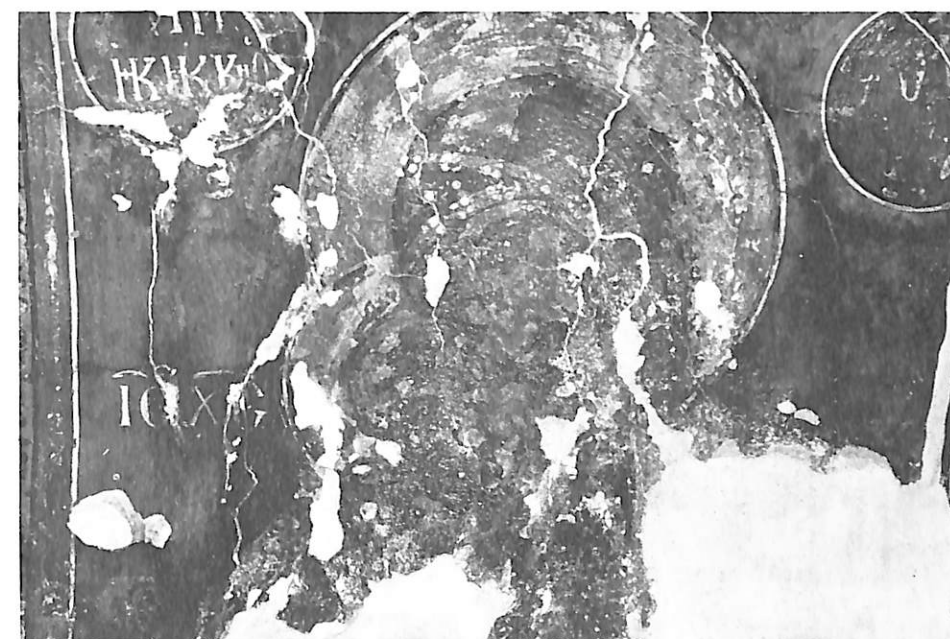
24. The same as above, after restoration work.
